# LESSONS LEARNED FROM MAJOR CORE DAMAGE ACCIDENTS

J. Hartung and P. Rutherford  
Energy Systems Group  
Rockwell International

## ABSTRACT

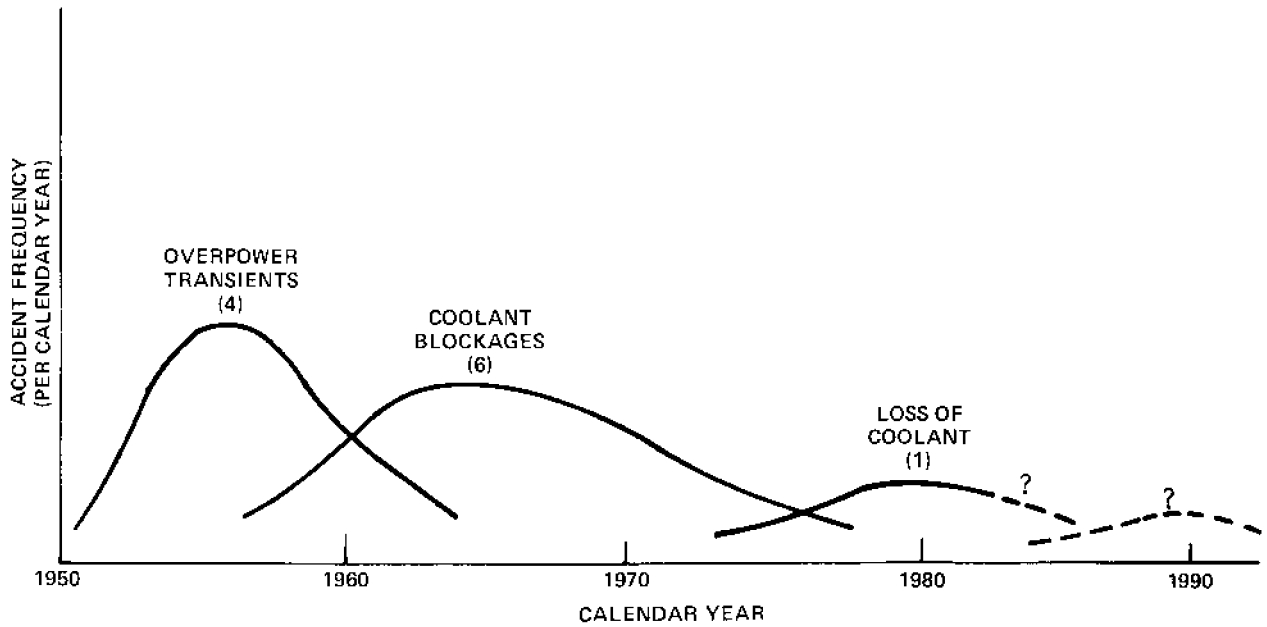
82-N5-103-1

Figure 1. Accident Chronology Suggests that Learning Can Help Prevent Recurrence of Similar Events

Of the 14 accidents, 4 involved overpower transients, 6 were caused by coolant blockages, 1 involved a loss of coolant, and 3 were of unknown or other causes. All four overpower transients (NRX, EBR-1, HTRE-3, and SL-1) occurred early in the development of nuclear power, between 1952 and 1961. All but one of the six coolant blockage incidents (SRE, ETR, Fermi-1, Lucens, and St. Laurent A-1 and A-2) occurred between 1959 and 1969. Apparently, the lessons learned from these accidents have helped prevent recurrences. This trend is illustrated schematically in Figure 1.

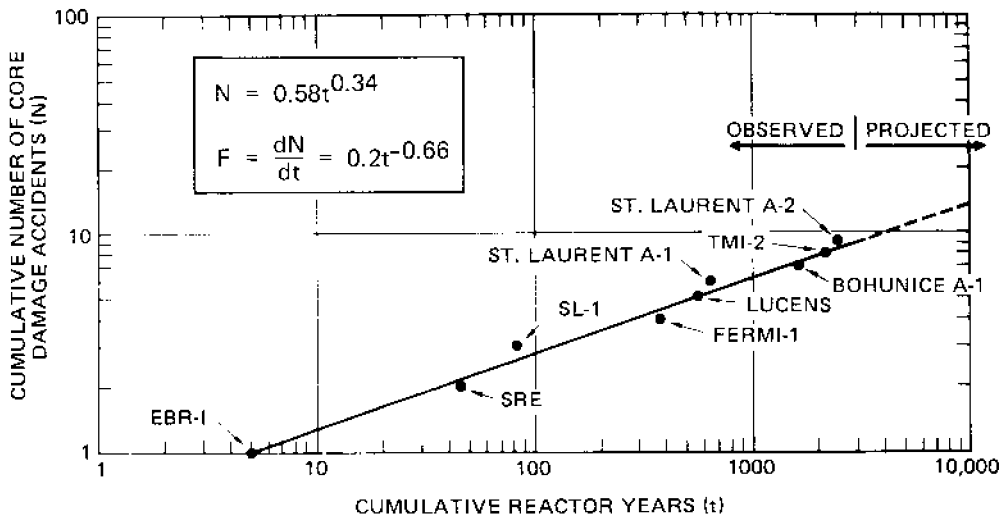
82-N5-103-2

Figure 2. Major Core Damage Accidents as a Function of Cumulative Operating Experience

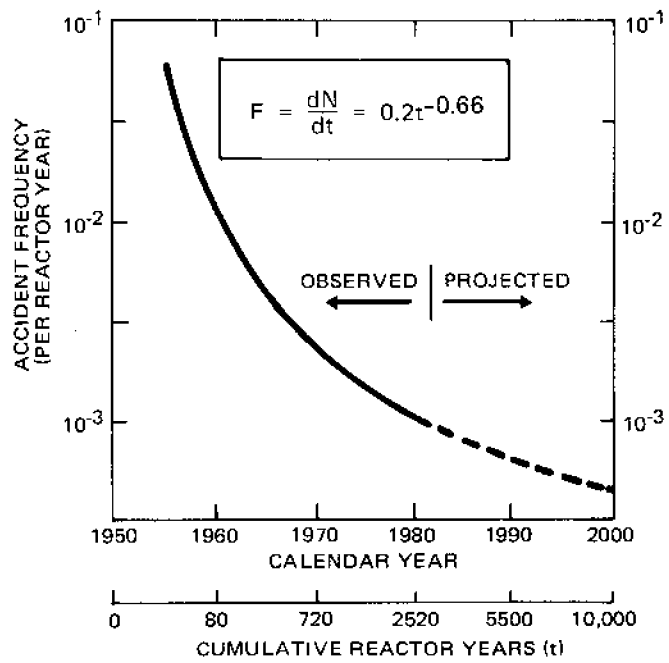
82-N5-103-3

Figure 3. Accident Prevention Learning Curve

Nine of the 14 accidents evaluated occurred in experimental, developmental, or commercial electricity-producing plants. The other 5 occurred in research, production, or propulsion reactors. To investigate the progress of the nuclear industry in learning to prevent accidents, a learning curve was developed from the major core damage accident experience in electricity-producing plants. The following procedure was used: (1) the observed number of accidents was plotted against cumulative experience on log-log paper (Figure 2); (2) the data were fit with a straight line (which is equivalent to assuming that accident frequency is proportional to cumulative experience raised to a power); and (3) the learning curve (Figure 3) was prepared based on this frequency function and the known and projected cumulative worldwide nuclear power plant experience by calendar year. Similar learning curves have been observed in other industries.<sup>40</sup> This learning curve is also similar to one previously developed in Ref. 41.

The learning curve in Figure 3 is thought to be indicative of past progress toward and future prospects for preventing major core damage accidents at nuclear power plants. This curve is an estimate of the average frequency of

major core damage accidents for all operating reactors in a given year and is not a good estimator of the reliability of a single plant or small group of plants. Commercial LWR power plants have apparently fared somewhat better than the average of all plants as evidenced by one major core damage accident (TMI-2) in over 1500 reactor years of operation worldwide. However, even this accident frequency needs to be reduced. Because the learning curve in Figure 3 is a (smoothed) average curve, it depicts a continuous learning process, whereas actual learning can probably also produce "step" improvements in reliability. It is to be hoped that the current emphasis in the nuclear industry on accident prevention will result in such a step improvement.
